## **Bolloré Transport & Logistics, Ghana. Cyanide Warehouse Pre-Operational Audit.**

### **Summary Audit Report.**

Bolloré Ghana Cyanide Warehouse  
Name of Facility

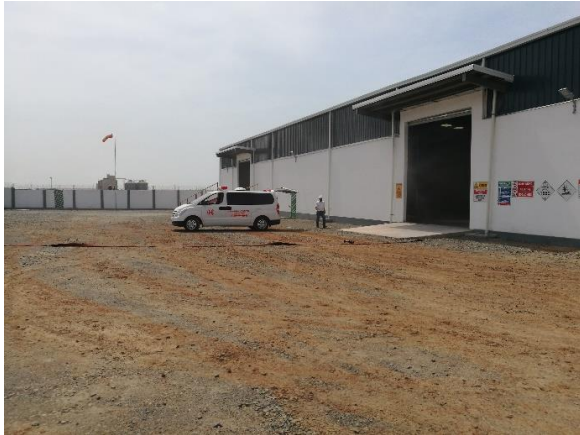
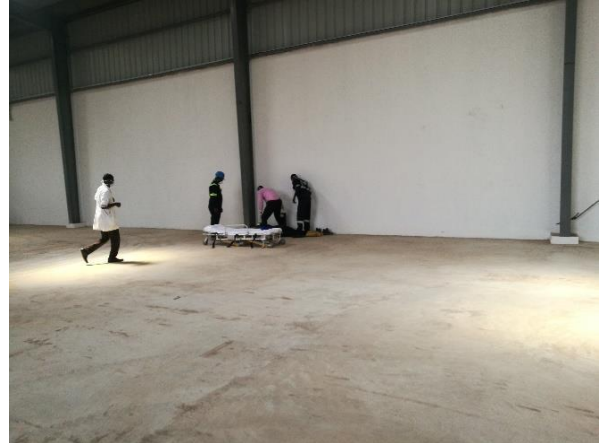
Under clear weather conditions the two roll-up doors are kept open to ensure proper ventilation through the building. Both the roll-up doors of the warehouse building are also closed during bad weather conditions such as sandstorms, rainy weather, or even if it appears that rain is to come down or when rain is predicated.

This warehouse is currently used for the storage of redundant cyanide packaging (timber boxes, damaged pallets and used plastic wrapping). The aforementioned is stored on the concrete floor until such time as it has to be incinerated. During day time the two access doors are kept open with supervision from the member working in the warehouse. At night time the doors are lowered and locked.
