ICMI RECERTIFICATION SUMMARY AUDIT REPORT

Goldcorp Inc. Porcupine Gold Mines, Timmins, Ontario, Canada

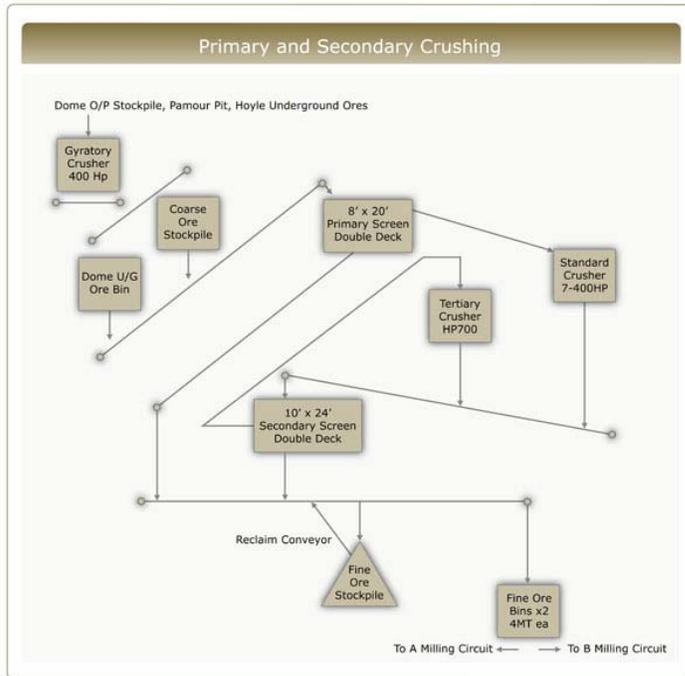
At the Dome mill, ore from PGM's mining operations is crushed in three stages to produce a product size of 80% passing ½". Primary and secondary crushing is achieved in a 400 HP 42"x 65" gyratory and 400 HP 7' standard cone crusher, respectively. The latter feeds a 10' x 24' double deck screen in a closed circuit with a HP700 cone crusher. The screen undersize reports to two 4,000 tonne fine ore bins and the oversize is conveyed to a 75 tonne tertiary surge bin feeding the HP700 cone crusher. Due to the limited fine ore bin capacity, an external fine ore stockpile and reclaim conveyor system provide for supplemental mill feed during extended shutdowns of the crushing plants.

Figure 1: Primary and Secondary Crushing

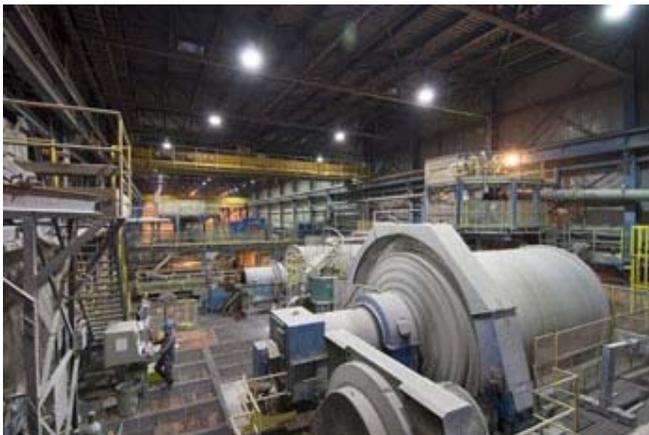
Minus 1/2" material is fed to a grinding circuit that consists of two parallel grinding lines. Circuit A consists of a 10.5' diameter x 14' 700 HP rod mill and 13.5' x 20' 2200 HP ball mill while Circuit B consists of a 15' diameter x 20' 2200 HP rod mill and a 16' x 28.5' 4500 HP ball mill. Gravity gold is recovered by the use of five Knelson CD-30 Concentrators fed from the cyclone underflow. A Consep CS6000 Acacia Reactor is used to intensively leach the Knelson concentrate. The Acacia loaded solution has a dedicated electrowinning circuit. Gravity recovery accounts for up to 45% of the recovered gold, depending on ore type.

Figure 2: Grinding Circuit A

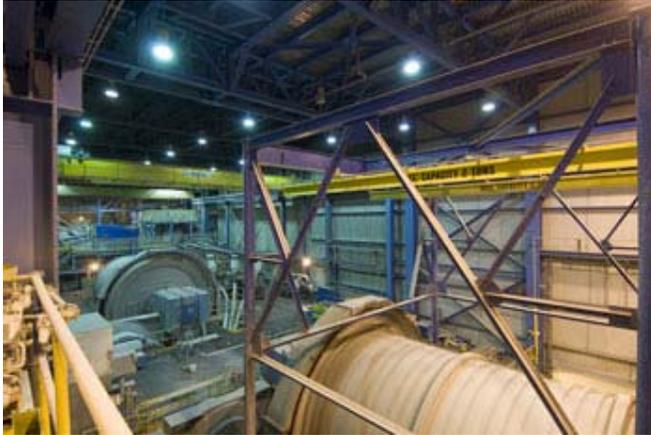
Figure 3: Grinding Circuit B

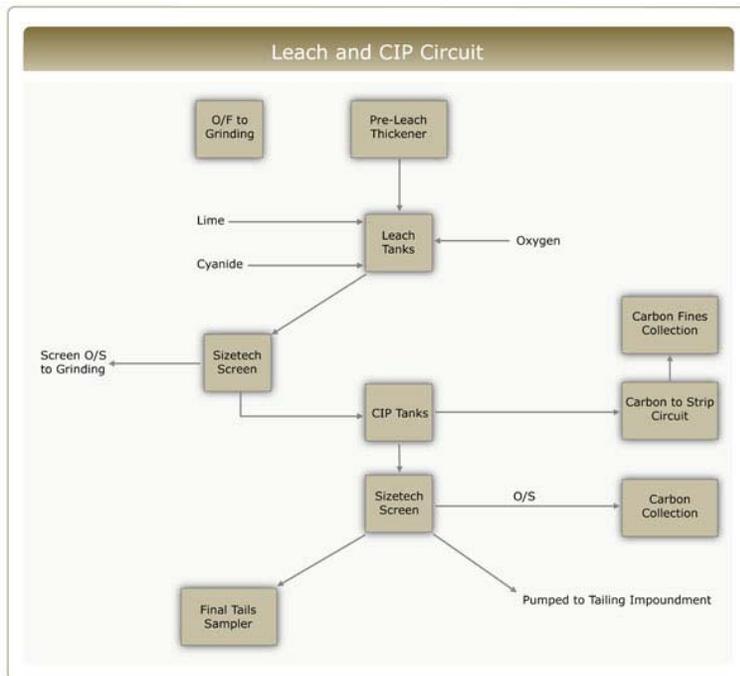
Lime is added to the mill discharge pump boxes, thickener feed well, as well as staged addition points in the leach circuit to maintain a pH of 11.5 during cyanide leaching. Cyanide is added to the first tank of the leach circuit. Staged oxygen addition maintains oxygen levels for optimum leach kinetics. After leaching, the slurry passes over a vibrating screen to remove any grit before being pumped to the CIP circuit where solution gold is adsorbed by activated carbon contained in the CIP tanks. Loaded carbon is removed from the tanks and stripped. A fine carbon collection system is in place to collect any fine carbon generated during the transferring and sizing stages and is periodically shipped to a smelter for refining. The elution process transfers the gold from carbon into solution. The solution is passed through electrowinning cells where gold attaches itself to a cathode in the form of high-grade sludge. The cells are cleaned by power washing the sludge off the stainless mesh, and the sludge is filtered, dried and then refined in an induction furnace.

CIP tails pass over a vibrating screen to collect any carbon which may have leaked past the inter-stage screens. This carbon is collected and returned to the CIP circuit. The final tails are sampled using an automated full stream sampler before being pumped to the tailing impoundment.

Figure 4: Leach and CIP Circuit

The cyclone overflows reports to a 155' thickener where the slurry density is increased to 55-60% solids. The thickener underflow feeds six leach tanks in series, which provide about 32 hours residence time.

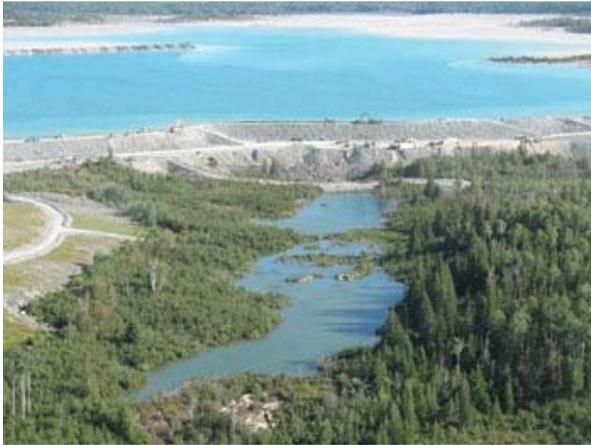
Figure 5: Dam Construction and Rehabilitation – 1

Construction of the No. 6 tailing facility began in 1983 and has been raised in stages since that time with engineered dams constructed using local fill materials. In 1997, an emergency spillway was constructed on the east side of the north dam to replace the old style decant structure.

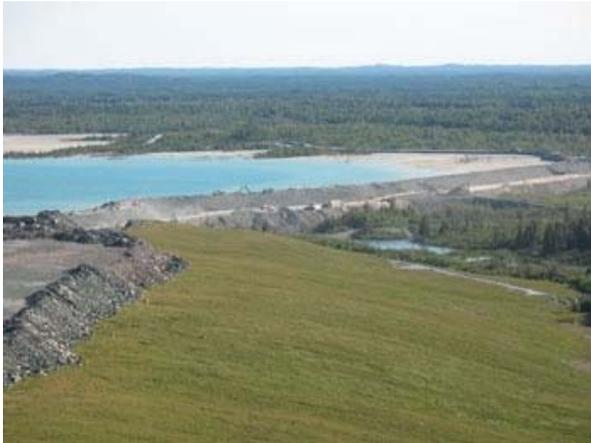
Figure 6: Dam Construction and Rehabilitation – 2

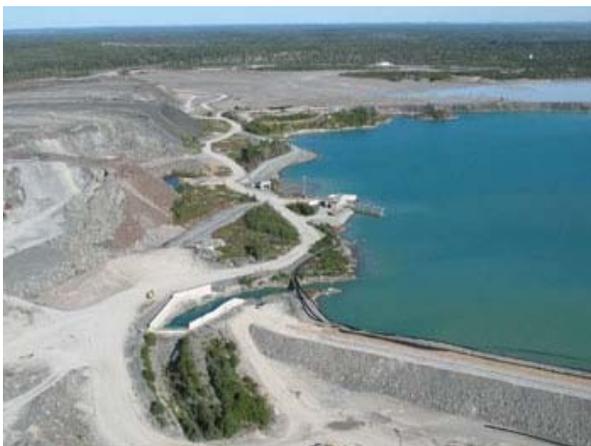
Figure 7: Tailings Dam Spillway and ETP

Currently, mill process water is comprised entirely of water reclaimed from the tailing impoundment; previously, reclaim water accounted for about 95% of the mill process water. Excess water in the impoundment is treated prior to being discharged to the environment. The Effluent Treatment Plant (ETP) operates each year between May and October, and uses sulphur dioxide and air to destroy any residual cyanide and ferric sulphate and lime are used to precipitate heavy metals. A 105' diameter x 16'-9" reactor clarifier separates the precipitated sludge which is pumped back into the tailing impoundment where it is co-deposited with the tailing. The clear overflow is further treated with EDTA and carbon dioxide to control to regulatory limits.
